Manhole Inspection Summary

Manhole # S21C__019MH

Insp Date: **4/23/09 3:37 PM**

Location Address: **500 MONROE ST**

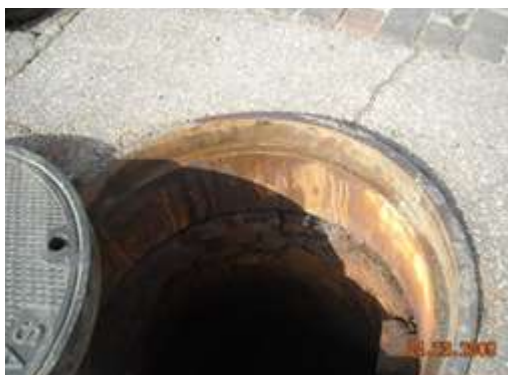
Subject To Ponding: **Sheeting**

SHEETING

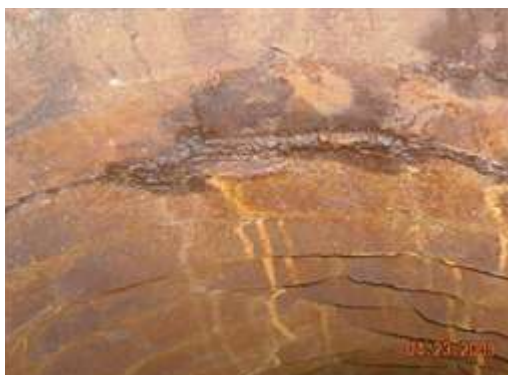
Defect 8

Condition: ☐ Sound ☒ **Cracked** ☐ Root Intrusion ☐ Loose Brick ☐ Deteriorated

CRACKED CORBEL WALL - MISC PIPE INTRUSION CLEAN WATER TAP

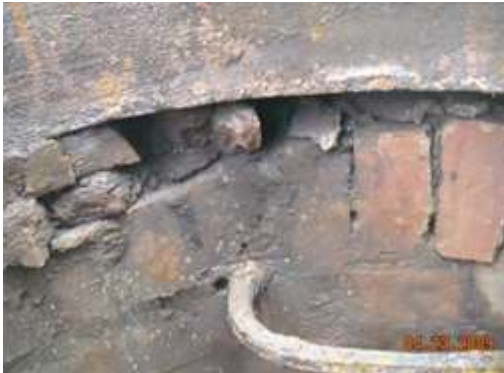
Defect 4

Frame Offset: **2** (in.) Condition: ☐ Sound ☐ Cracked ☒ **Leaks**

FRAME LEAKS

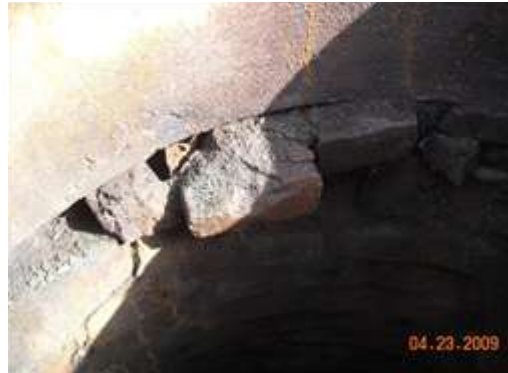
Defect 3

MISSING BRICKS IN CHIMNEY

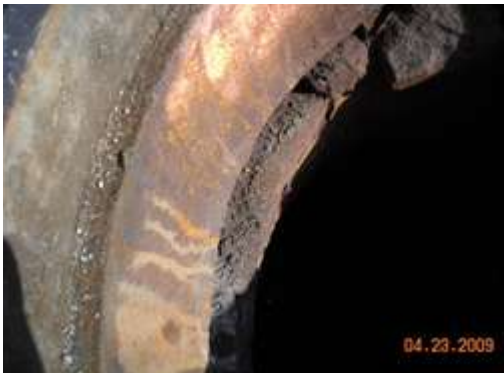
Defect 2

Condition: ☐ Sound ☒ **Cracked** ☐ Root Intrusion ☒ **Loose Brick** ☒ **Deteriorated**

LOOSE BRICKS IN CRACKED CHIMNEY

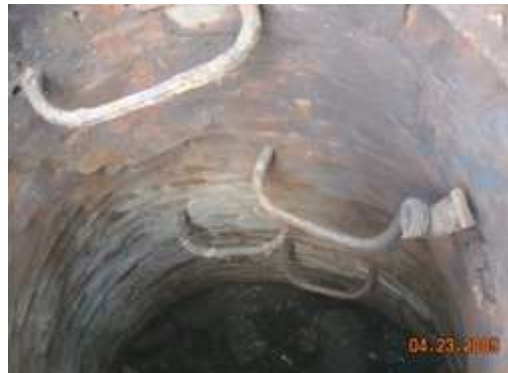
Defect 1

FRAME OFFSET 2"

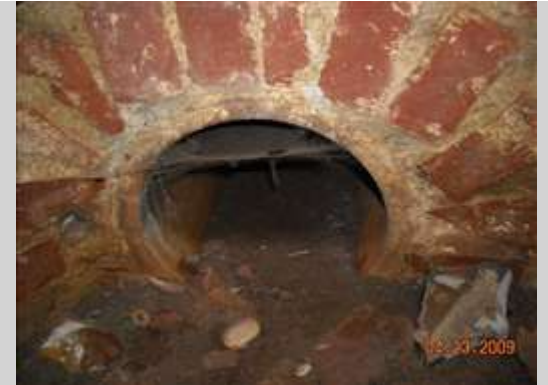
12 O'Clock Outflow

8 in. Circular Gravity Sewer
Pipe Out @ 12 O'Clock

Deposits: ☐ None ☐ Mud ☐ Sludge ☒ **Debris** ☐ Grease

Silt Depth: **2** (in.) Deposits Extent: **Light**
